Field Demonstration of a 24-kV Warm Dielectric Superconducting Cable at Detroit Edison

FY2003 Annual Progress Report

Technical Update, March 2004

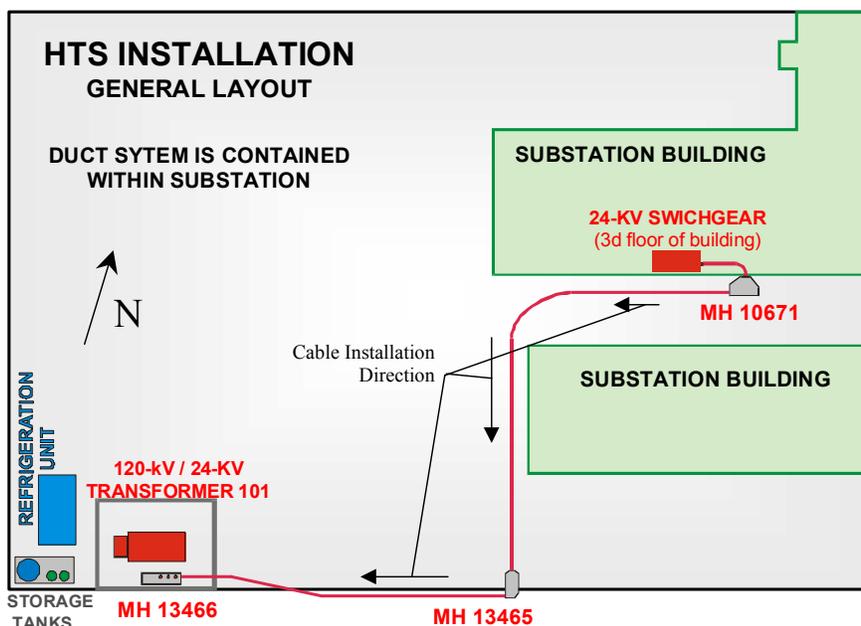
Figure 1. Cable Site Layout

The demonstration cable circuit runs approximately 120 m between the 24 kV bus distribution bus and a 120 kV-24 kV transformer. This location for the demonstration site was selected because it combined performance specifications suitable for the application of an HTS cable circuit and several practical advantages. Though the route is not as long as is anticipated for commercial applications and is completely contained within Detroit Edison's property, it offered many challenges similar to those that will be faced in other field installations. Figure 1 shows the station layout and the installation route.

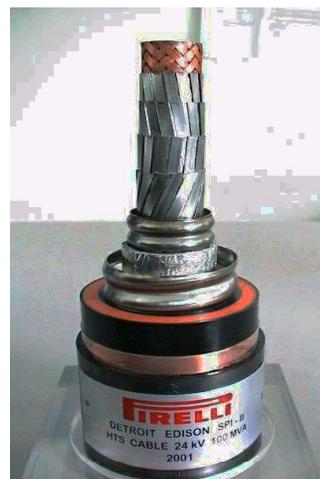
Figure 2. Cable with Features Displayed

The 24 kV cables were designed and built using the Warm Dielectric (WD) design concept, which places the dielectric material outside the cryostat, so that it operates at ambient temperature. This enabled the use of a conventional dielectric, EPR, for the cable insulation. The system also proposed to demonstrate accessories, including terminations, an installation joint, and a repair joint. Figure 2 shows a cross section of the cable construction with its primary features visible.

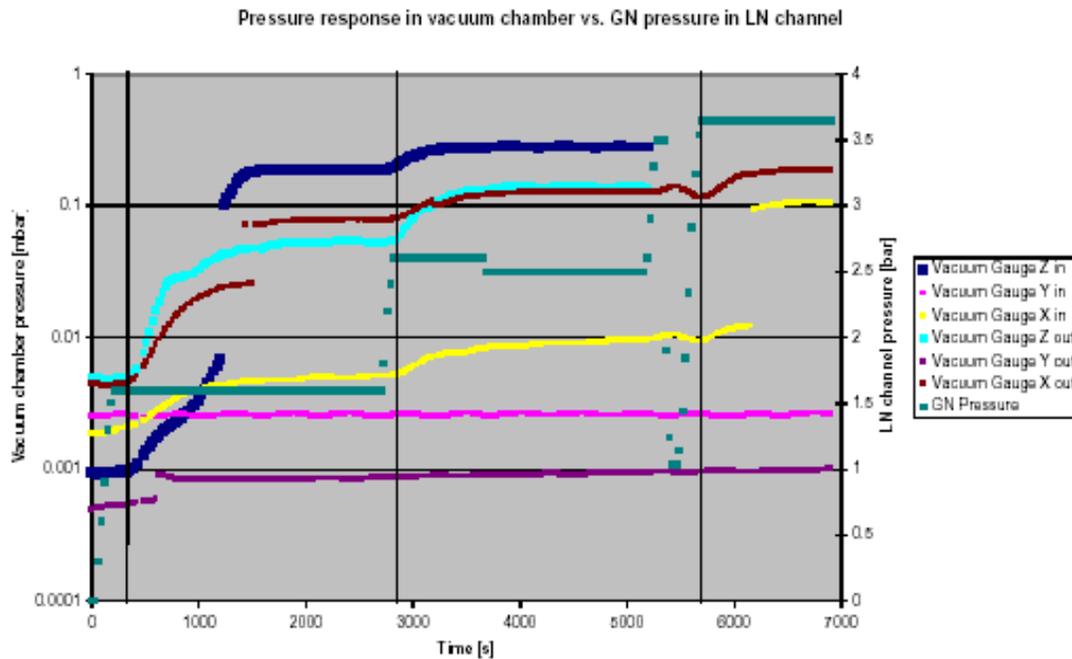
Figure 3. Pressure response in vacuum chamber

Therefore, pressure variation response tests were conducted on each conductor phase. Using different pumping groups, the cryostats and conductor space inside of the inner corrugated tubes were evacuated. After evacuating the conductor space (thereby minimizing leaks between the conductor space and cryostat), an improvement in vacuum level of phases X and Z was recorded. All the conductor spaces were pressurized with gaseous nitrogen (GN) @ 1.6, 2.6 and 3.6 bar. An immediate vacuum pressure response was recorded on phases X and Z. Before increasing pressure in the conductor space from one level to the next, the pressure in the cryostat was allowed to reach a plateau. Pressure was monitored from each end of the cryostats. See Figure 3. Note that Vacuum gauge X out was not working properly.

1. Phase X and Z vacuum gauges' response could give an indication on leak position, but their responses being almost equal in time but at different level, could indicate:
 - Leaks of different size on both terminations;
 - Leak inward on phase Z and outward on phase X.
2. Phase Y didn't show any response to pressure variation.

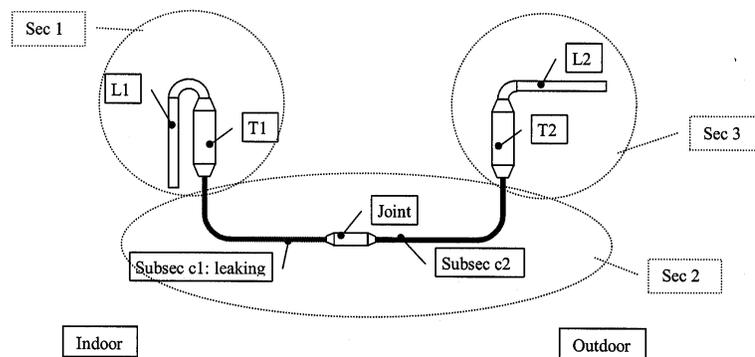
Figure 4. Test sections and subsections

These components were sent to the Frisbie site and investigation was begun and completed on Phase X. Figure 4 is used as a reference diagram for describing this investigation.

A summary of the leak detection tests described above for Phase X is shown in Table 1. (Refer to Figure 4 for section locations).

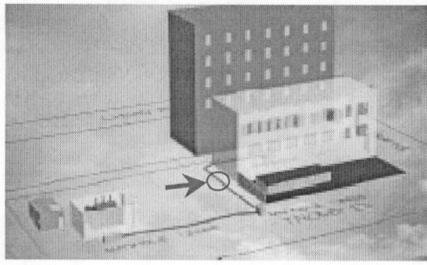
Figure 5. Leak position – perspective. **Figure 6. Leak position - plan**

In conclusion, the tests indicate that the leak(s) should be located approximately 16-22 meters from the splice, or 42-48 meters from the indoor termination, as illustrated on site diagrams (Figures 5 & 6 below).

Estimated leak position

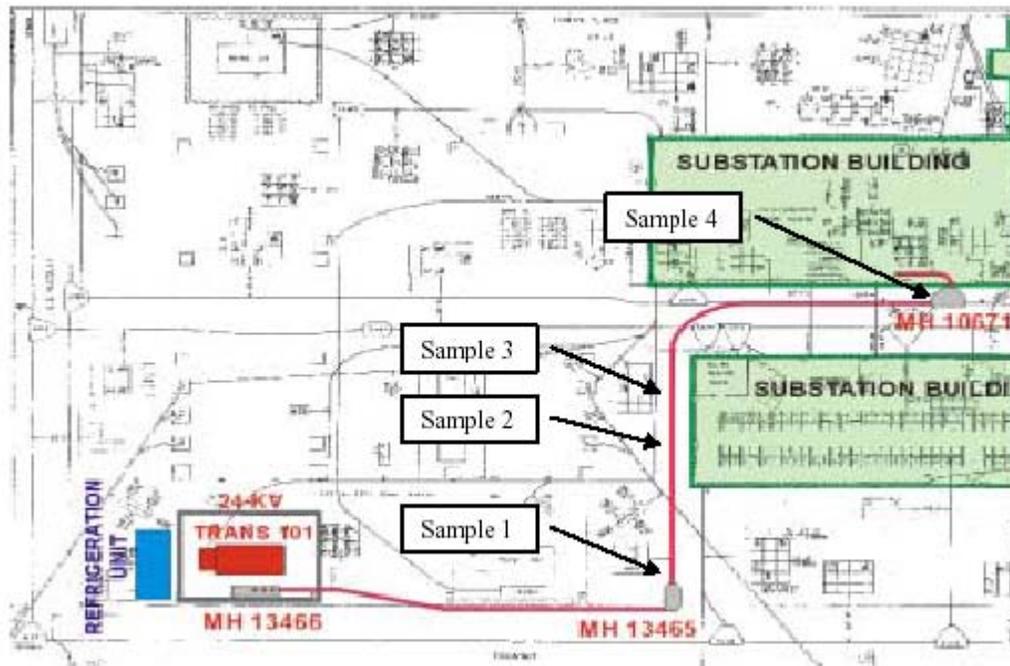
Fig. 7. Samples location

Using He mass spectrometry, leaks in the inner cryostat tubes were located. Four sections of the cryostat around leak locations, each approximately 0.4 m in length, were removed and taken to the laboratory for microscopic analysis. The position of each of the four sampled sections, as they would have been located at Frisbie is noted in Figure 7.

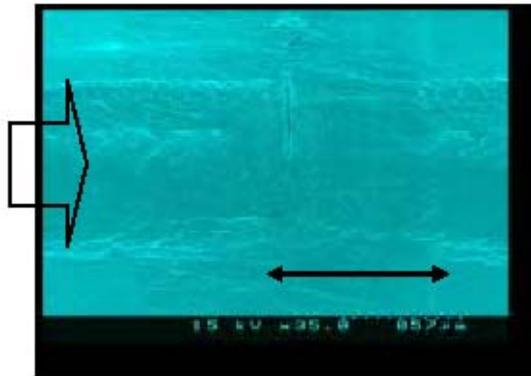
Fig. 8. Tube sample 4, crack along the welding.

The pictures taken using the SEM best document the appearance of the defective spots. As can be seen in the example Figures 8 to 13, the largest cracks were all found to extend parallel to the axis of the tube, and to be typically visible on the outside surface.

In all the above documented cases, the cracks seem to have initiated from the outer surface, where there appears to be a small and smooth V-shaped groove. Such a feature, which is better evident from the micrographic optical observation, was searched for in other parts of the welding along the tube, inside other corrugation grooves adjacent to the crack location, and found to be absent.

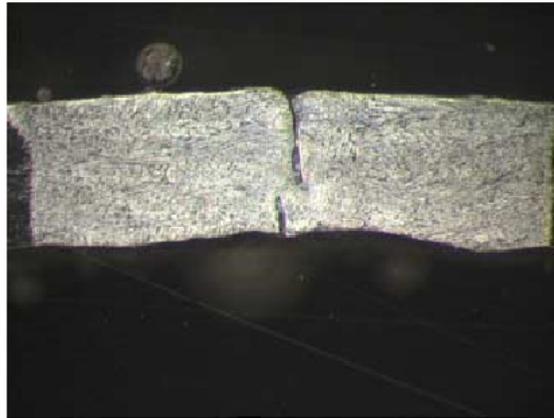
Fig. 16. Crack in tube 1

As can be observed, the fracture line, which is located quite in the center of the weld (the anvil-shaped, lighter region in Figure 16), is rather “broken”, and seems to suggest that the fracture might have occurred in two steps. The crystalline structure that is well visible at higher magnification (shown in Figure 16) does not show particular anomalies, and is quite similar to the one found in other samples taken from a non-defective welding region.

In one case it was possible to prepare a metallographic sample that included a crack in its full extension. The fracture path followed a broken line, strongly indicative that the crack was formed in two steps. This suggests that the fracture may be due to the combination of a mechanical stress and a defective, weaker point in the welding region.

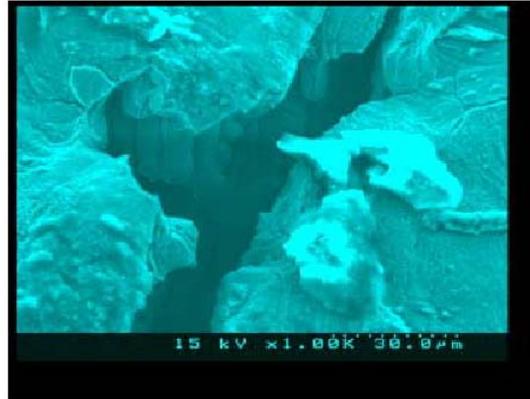
Fig. 19. Tube 1 detail of crack on inner surface

All the observed cracks strictly follow the interphase boundaries. This is supported by SEM observations of cracks opening at the outer surface (see Figures 19 and 20) showing interphase boundaries (dendrite nodules in Figure 21). This indicates that these defects were formed during the solidification process.

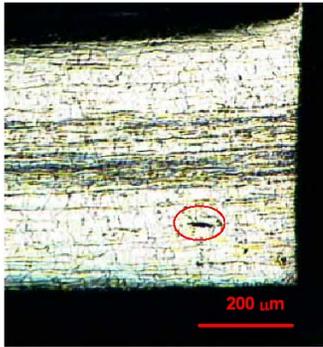
Fig. 22. Tube 1, outside the welding

Partial support to the above came from the additional observations that were carried out on a sample taken from a non-defective region of tube 1, from outside the welding and outside the corrugation groove. Careful metallographic observation in this sample showed also the presence of tiny defects like the ones shown in the Figure 22-25.

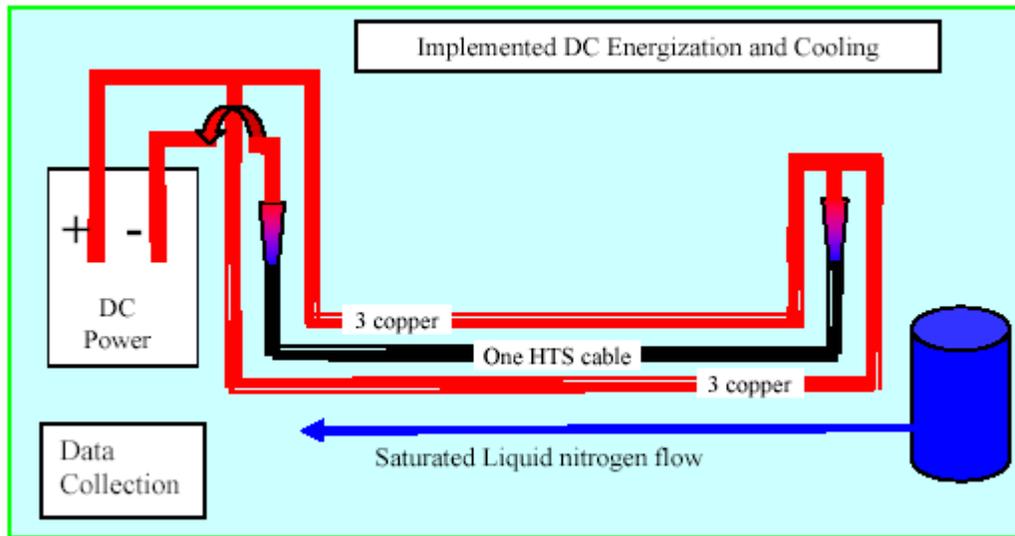
Figure 26. DC Test Configuration

In order to energize the cable with dc current, six 875A, 5V dc power supplies were shipped from Pirelli, Milan for connection in parallel. The dc current was to be passed along the cooled HTS cable and returned via the 6 copper cables connected in parallel. In this circuit the maximum system voltage available was 5V and maximum possible current 5250A dc. In initial tests it was discovered that the cabling provided to interconnect the DC power supplies and to connect to the cable terminations had too high resistance (given the 5V limit on the power supplies). A considerable effort was expended on Day #2 to shorten all these cables and double them up, to enable the power supplies to drive sufficient current through the system. The experimental set-up is shown in Figure 26.

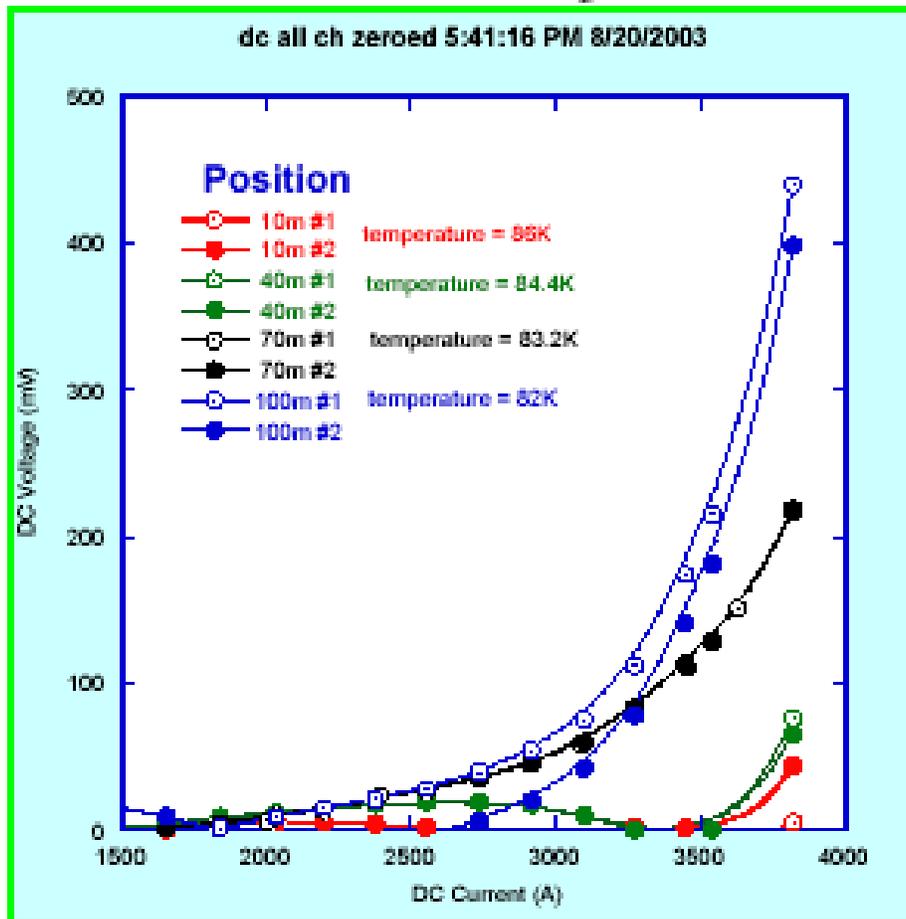
Figure 27. DC Test Results

Figure 27 shows the DC voltage measured at various points along the cable, all measurements are referenced to the voltage taps at '0 meter'. Note that the data is taken at slightly different temperatures due to the temperature variation along the cable. Also it should be noted that all these data are the voltage difference between that point and the '0 meter' point of the cable. For example, the '110-meter' voltage *includes* the '70-meter' voltage values. The noise on these measurements is significant, mainly due to the electrical environment in the Frisbie substation. Given more time it would probably have been possible to collect better data. The 10-meter and 40-meter data seemed particularly noisy.

On a 100 meter cable the critical current level of 1 microvolt per cm would yield 10 mV. Closer examination of the data presented above indicates that the critical current of the cable was approximately 2000 A at this temperature range. If we scale this to 77 K we might expect a critical current of 2800 A. There is some indication that a lower I_c region exists in the section between 40 meter and 70 meter (the 100 meter and 70 meter data show very similar behavior at currents below 2500 A, while the I_c up to 40 meter seems significantly smaller). However, the noise in the measurement makes this a tentative conclusion.

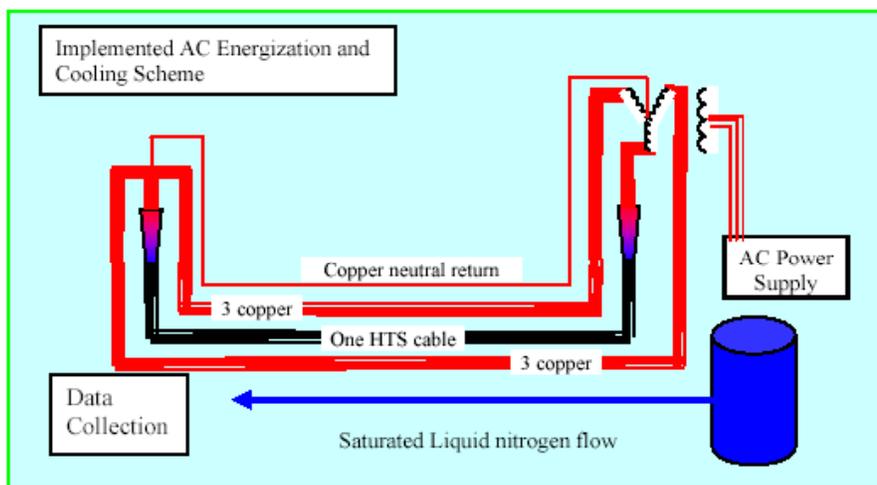
Figure 28. AC Test Configuration

The cable was energized in 3-phase configuration using the two installed “copper” phases in place of the non-operational HTS phases. The three phase conductors were connected to the low voltage side of a delta-wye transformer located at the ‘outside’ end of the cable. This transformer had a turns ratio of 8:1. The ‘inside’ ends of the three phase conductors were shorted together using a copper bus bar. This common point was linked to the neutral of the transformer winding using a copper cable. This allowed the return of any imbalanced current. The HTS cable shield was grounded at the ‘outside’ terminal, this was the only ground point in the circuit. The configuration is shown in Figure 28.

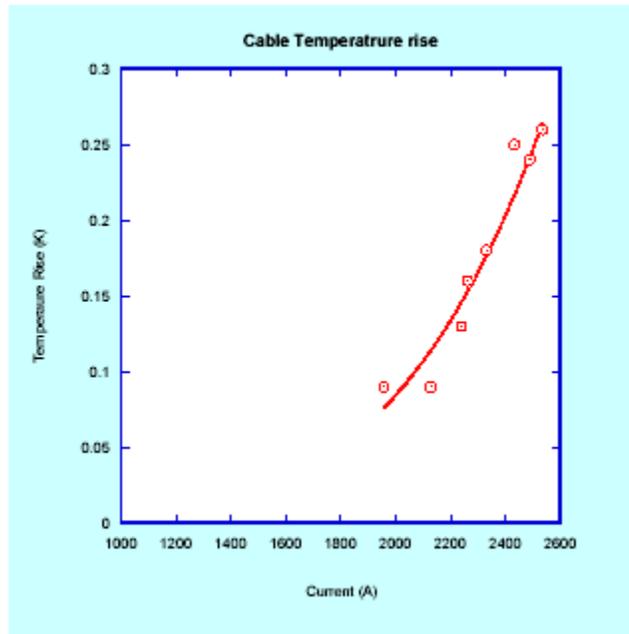
Figure 29. Cable temperature rise during ac loss test attempts

Neither of the intended ac loss measurement techniques yielded any data. During the attempts to make these methods work though, it was noticed that the cable temperature did change slightly when the ac current was applied, this was not seen during the dc tests. In Figure 29 we show the cable temperature rise at the 100m point along the cable (i.e. 100m from liquid nitrogen inlet).

The reason for the increase in temperature is not straightforward. The liquid nitrogen is boiling at all points along the cable; consequently an increase in temperature indicates an increase in pressure at that point. A higher pressure in the cable indicates higher viscosity in the two phase liquid flow downstream, caused presumably by a greater percentage of vapor in the flow compared to liquid – due to the higher heat input from the ac losses. In principal some estimate of the ac losses could be made from this data, but this was not thought to be worthwhile as it would be very approximate. Moreover, given the distorted waveform of the current the results would not be meaningful (there are many frequency components present, most particularly the 3.5kHz). However, some *minimum* value for the losses can be given. If we assume all the ac loss energy is used to raise the temperature of the two-phase liquid nitrogen flow, and not to vaporize more liquid, we find losses of approximately 35W for the whole cable length at a transport current of 2500A.
